**SITE ASSESSMENT REPORT
AND REMOVAL COST ESTIMATE
FOR
AUTODEPOSITION INC. SITE
CHICAGO, COOK COUNTY, ILLINOIS
TDD: T05-9505-018
PAN: EIL0889SAA**

September 8, 1995

**UNITED STATES ENVIRONMENTAL PROTECTION AGENCY
Emergency and Enforcement Response Branch
77 West Jackson Boulevard
Chicago, Illinois 60604**

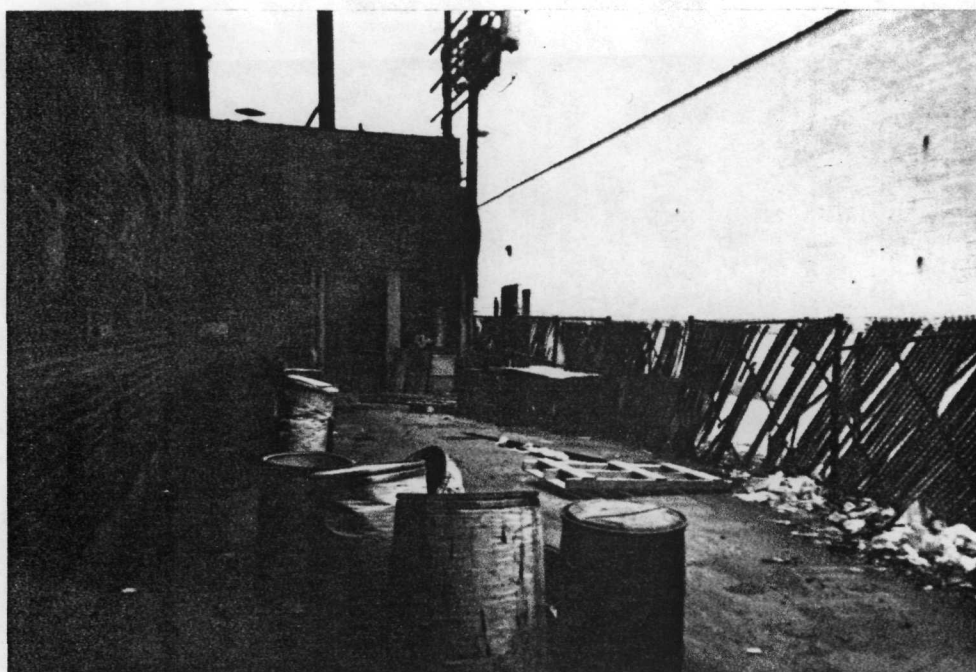
Fenced in area located in the northeast corner of the ADI site. A 5,000-gallon capacity tank, containing approx. 2,500 gallons of sulfuric acid and several drums are located in this area.

Samples collected by TAT indicate that hazardous materials are present on site. Many of the 55-gallon drums and plating/immersion/pH adjustment vats found on site are open and contain hazardous material. Several drums are overturned, and many are in poor condition, posing the possibility of release. The 5,000-gallon sulfuric acid tank, stored above ground outside the building, is rusting, and, if a release should occur, an immediate threat to the population would occur. The pH of a substance on the ground outside the building was determined to be approximately 13. The presence of leaking drums in this outside area poses an immediate threat of release to the environment.

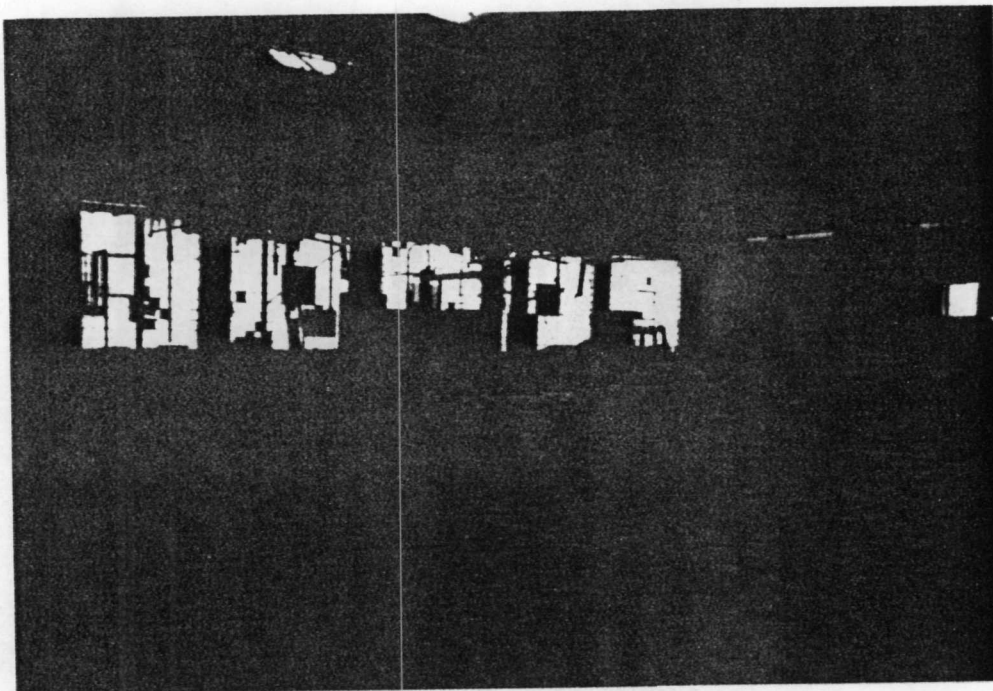
SITE NAME: AUTODEPOSITION, INC. TDD #: T05-9505-018
 PHOTOGRAPHER: Imes CAMERA: Ritz Quick Snap - 35mm
 DATE: 06/01/95 TIME: 1000
 DIRECTION: Southwest
 SUBJECT: Room 1 in on-site building. Room formerly housed zinc, nickel, and copper-cyanide plating line. Vats have been removed, however drums and one-cubic yard boxes are staged in the room.

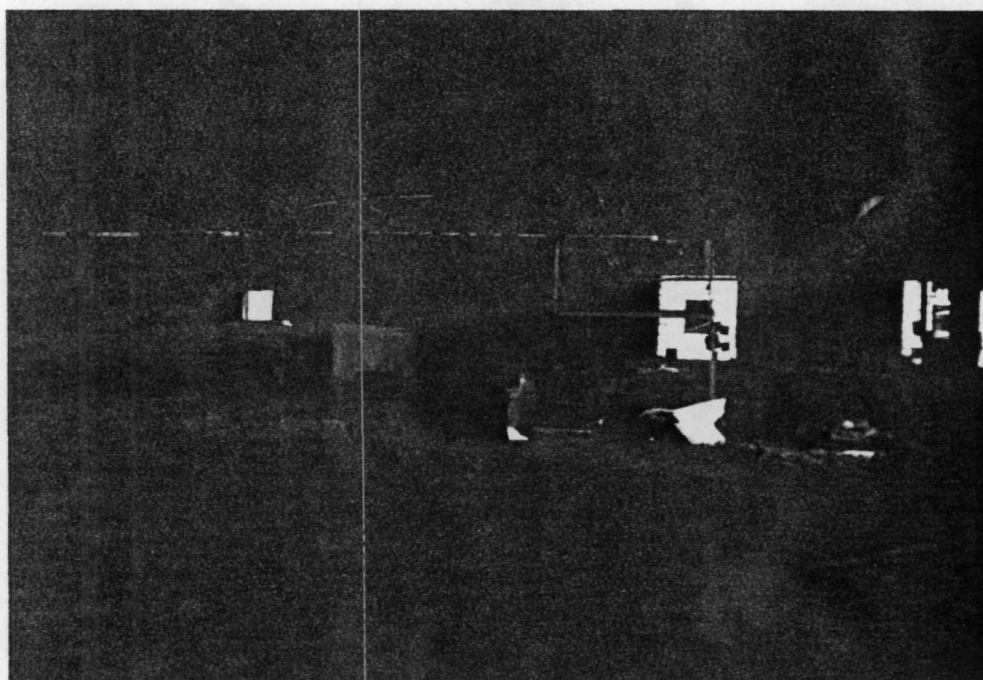
SITE NAME: AUTODEPOSITION, INC. TDD #: T05-9505-018
 PHOTOGRAPHER: Imes CAMERA: Ritz Quick Snap - 35mm
 DATE: 06/01/95 TIME: 1005
 DIRECTION: West
 SUBJECT: Room 1 in on-site building. A 2,500-gallon tank containing acid is located adjacent to the west wall. Visible staining on the floors and walls were observed.

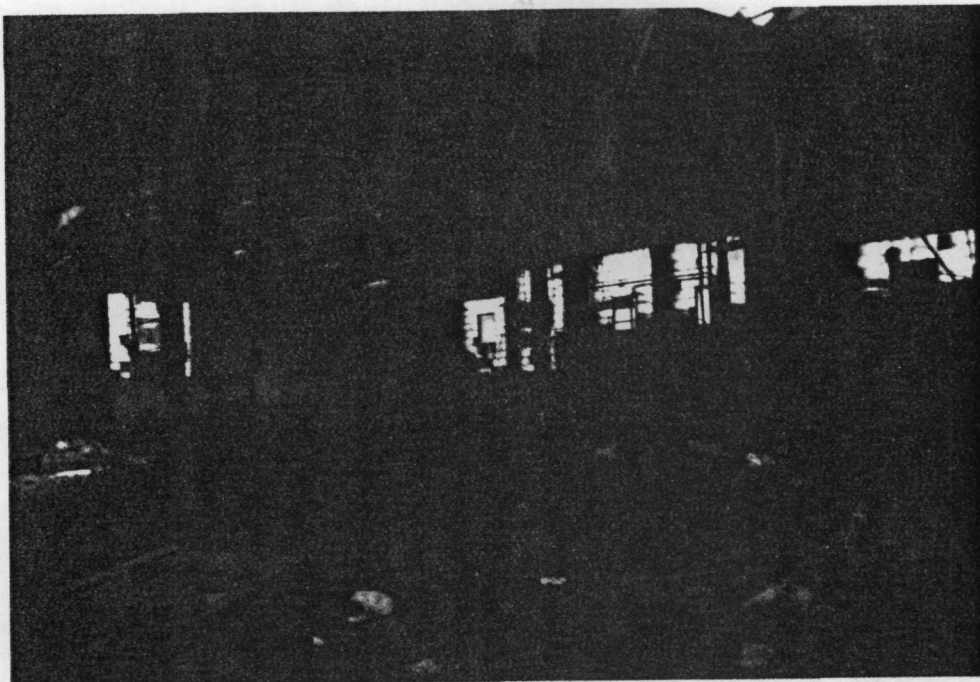
SUBJECT: Room 1 in on-site building. Several drums containing alkaline zinc, crystallized copper cyanide and nickel black solutions stored in the northwest corner of the room.

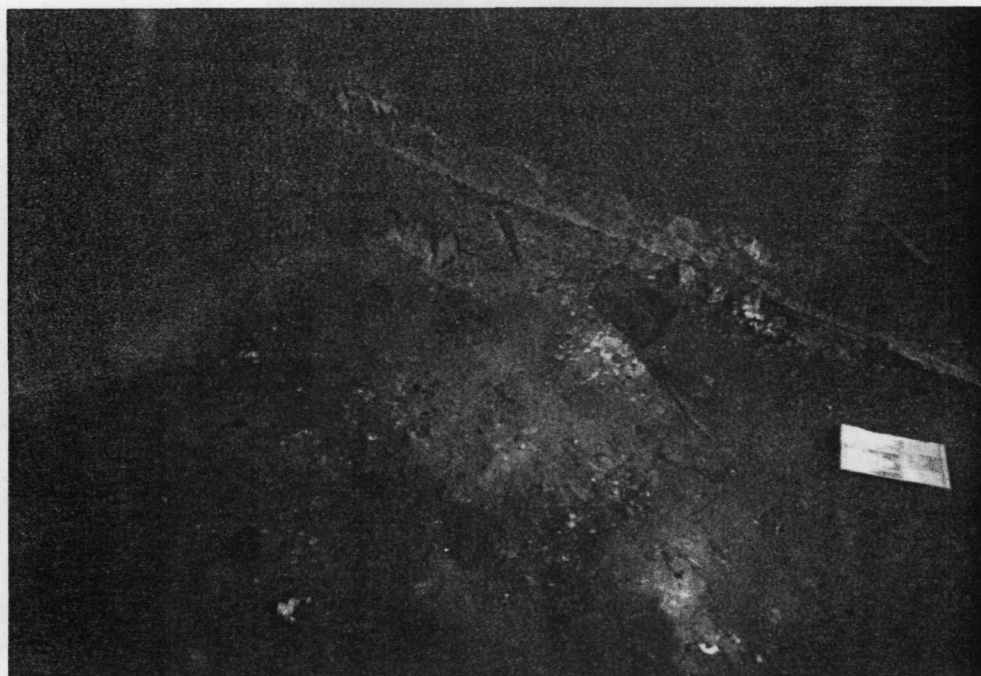
Sample FL-001. Composite sample FL-001 was collected from materials scattered on the floor in Room 1. High levels of total cyanide were reported (1,200 mg/L). Reactive cyanide was reported as non-detect. FL-001 also exhibited hazardous levels of TCLP cadmium at 58 mg/L. Copper, nickel, and zinc TCLP levels were 5.8 mg/L, 230 mg/L, and 240 mg/L, respectively. Other metals that were present at elevated levels include chromium, lead, and mercury (Table 4-1).

SUBJECT: Floor inside of Room 1. Note: visible staining of concrete floor. A composite sample designated as FL-001 was collected from solid material scattered on the floor.

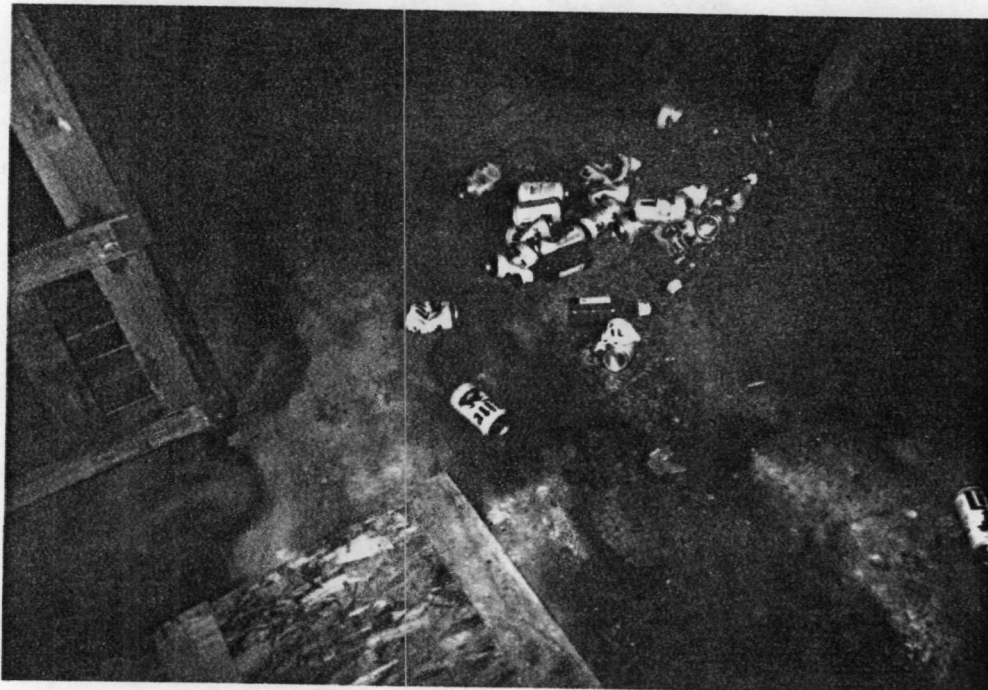
Access to the site is unrestricted, and entry by vagrants and vandals was demonstrated by the presence of beer bottles and food containers scattered on the floor of the building. Cyanide, as found in floor composite sample FL-001, may be rapidly fatal if inhaled or ingested. Symptoms of exposure include asphyxia; damage to the cardiovascular system, liver, skin, kidneys, and central nervous system; or death. Chromic acid is corrosive on contact or inhalation, and may cause severe irritation of the respiratory system. Chronic symptoms of exposure include skin ulcers and conjunctivitis. The presence of chromic acid on the outside of the building and on the sidewalk next to the building poses an immediate threat to the nearby community. Cadmium, found in high concentrations in floor sample FL-001, is known to cause damage to both the liver and kidneys. Cadmium is a suspected carcinogen, and is also linked to hypertension.

SITE NAME: AUTODEPOSITION, INC.
 PHOTOGRAPHER: Imes
 DATE: 06/01/95
 DIRECTION: Northeast
 SUBJECT: Beer bottles on the floor in Room 2 of the on-site building. Debris and food containers were scattered throughout the room indicating the building is unrestricted to vagrants.

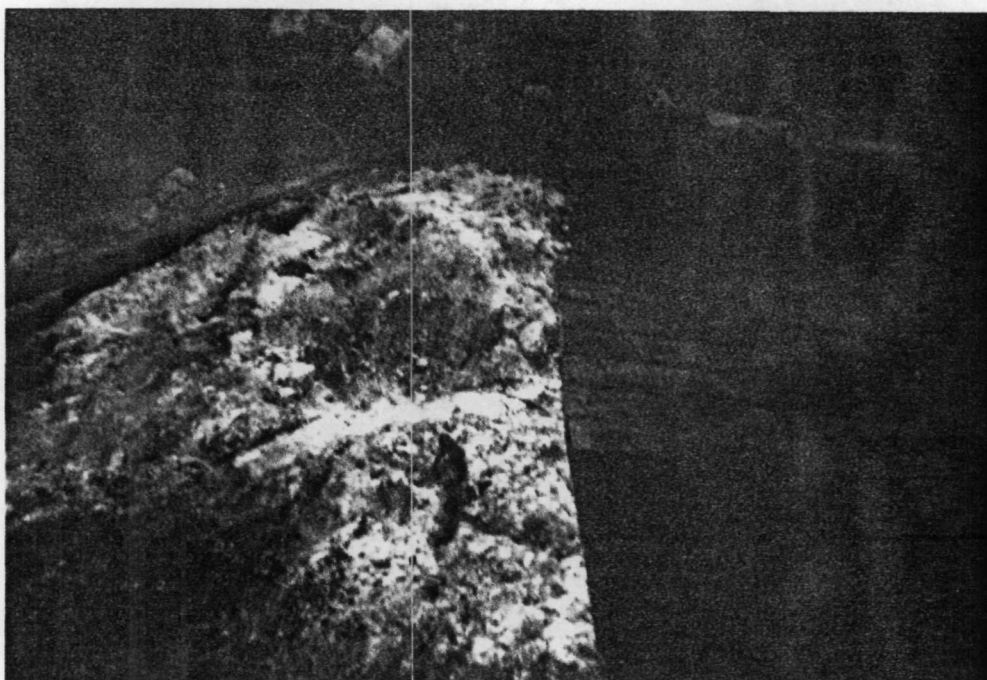
SITE NAME: AUTODEPOSITION, INC.
 PHOTOGRAPHER: Imes
 DATE: 06/01/95
 DIRECTION: N/A
 SUBJECT: Room 3 of the on-site building. White-powder material was scattered throughout the floor.

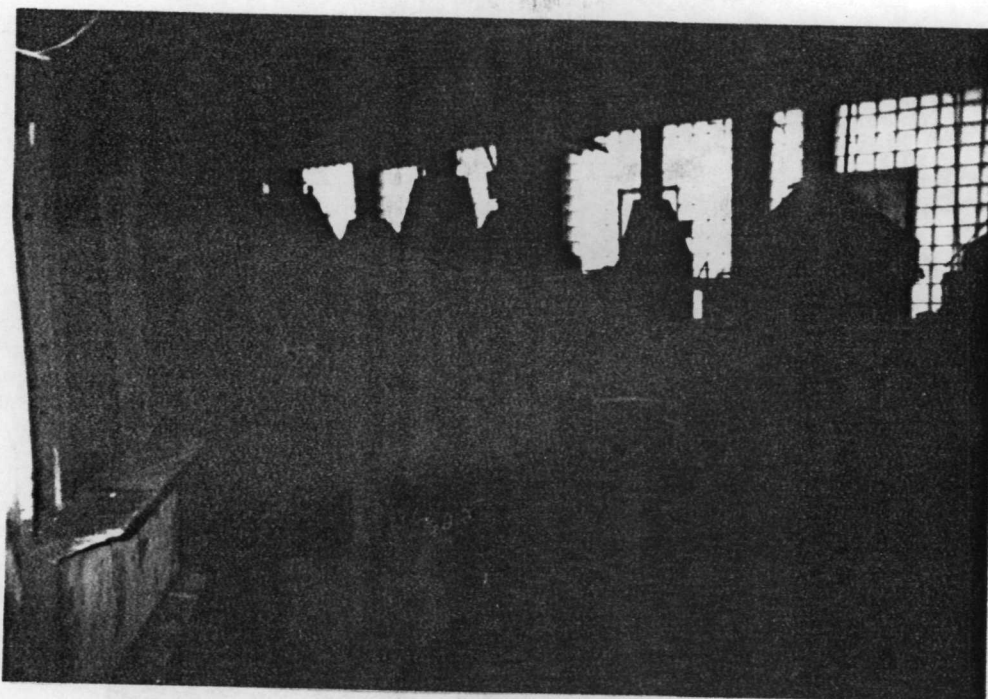
SITE NAME: AUTODEPOSITION, INC. TDD #: T05-9505-018
 PHOTOGRAPHER: Imes CAMERA: Ritz Quick Snap - 35mm
 DATE: 06/01/95 TIME: 1035
 DIRECTION: East - South east
 SUBJECT: Room 3 containing over 100 drums of chromic acid solution and over 50 Vats.
 Room formerly housed the chrome plating line. Several vats contain material.

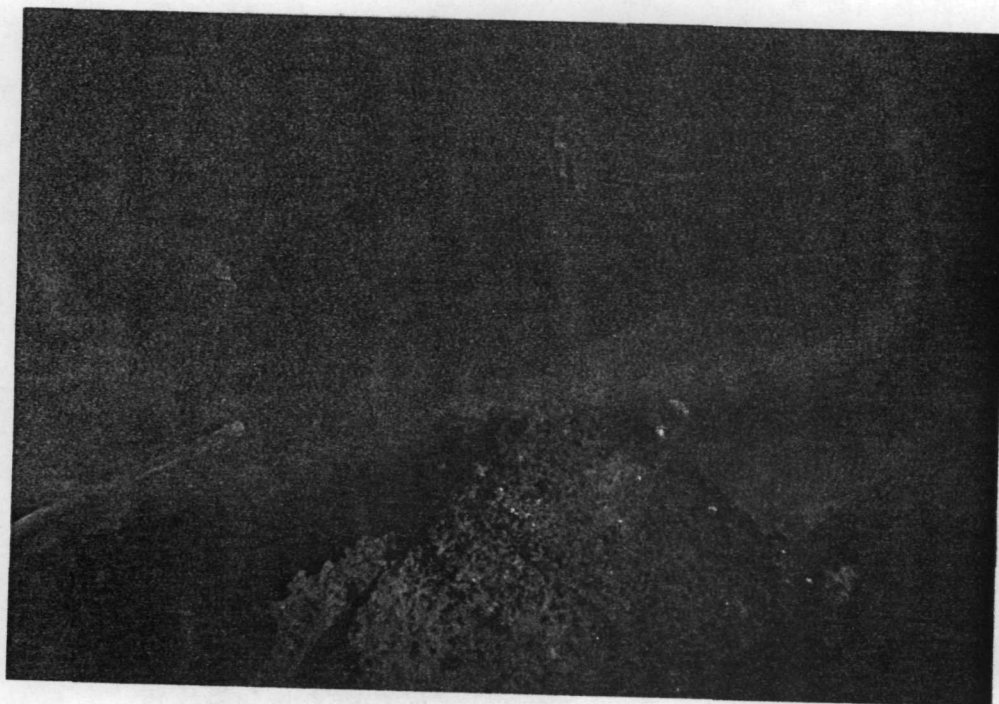
SITE NAME: AUTODEPOSITION, INC. TDD #: T05-9505-018
 PHOTOGRAPHER: Imes CAMERA: Ritz Quick Snap - 35mm
 DATE: 06/01/95 TIME: 1040
 DIRECTION: South
 SUBJECT: Chromic acid on floor in room 3 of on-site building. Several drums appeared to be
 leaking their contents onto the floor. Solution revealed a pH of < 1 standard unit.

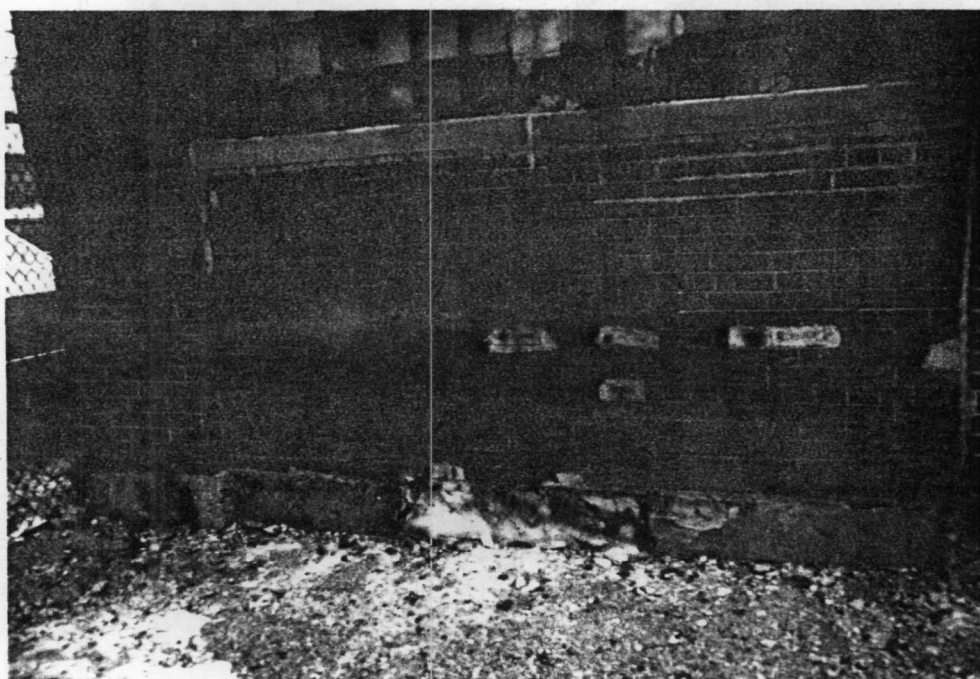
The site conditions outside of the Autodeposition facility were also photodocumented by TAT. Staining was visible along most of the south wall of the Autodeposition building. The staining observed by TAT was also present on the sidewalk, especially adjacent to cracked and deteriorated sections of the south wall. A sample was collected from the south side of the building outside room 3.

SITE NAME:	AUTODEPOSITION, INC.	TDD #:	T05-9505-018
PHOTOGRAPHER:	Brooks	CAMERA:	Ritz Quick Snap - 35mm
DATE:	06/02/95	TIME:	1300
DIRECTION:	North		
SUBJECT:	South side and west end of ADI site. Note staining of brick.

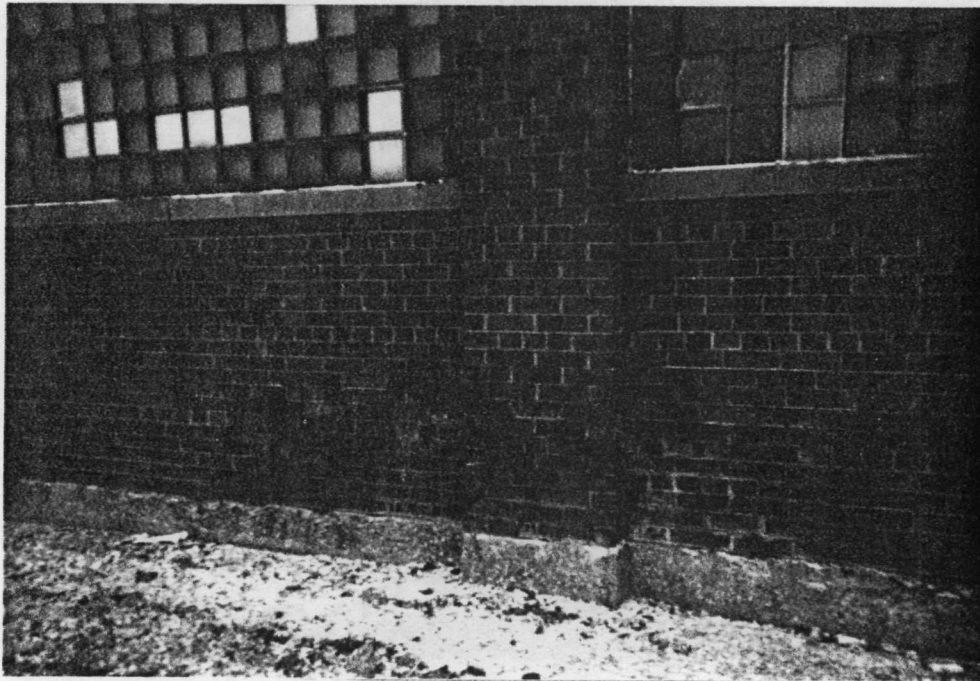
SITE NAME: AUTODEPOSITION, INC. TDD #: T05-9505-018
 PHOTOGRAPHER: Brooks CAMERA: Ritz Quick Snap - 35mm
 DATE: 06/02/95 TIME: 1303
 DIRECTION: North
 SUBJECT: South side of ADI site at the center of the building. Note staining of brick and deterioration of the structure.

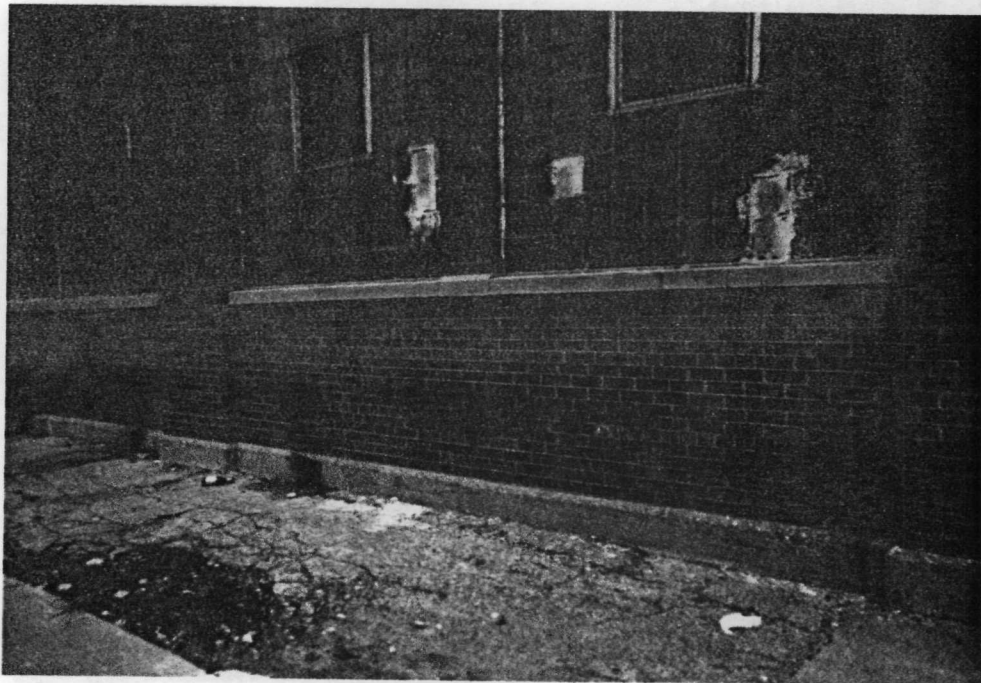
SITE NAME: AUTODEPOSITION, INC. TDD #: T05-9505-018
 PHOTOGRAPHER: Brooks CAMERA: Ritz Quick Snap - 35mm
 DATE: 06/02/95 TIME: 1305
 DIRECTION: North-Northwest
 SUBJECT: South side of ADI site at east end of building. Note staining of brick and broken windows.

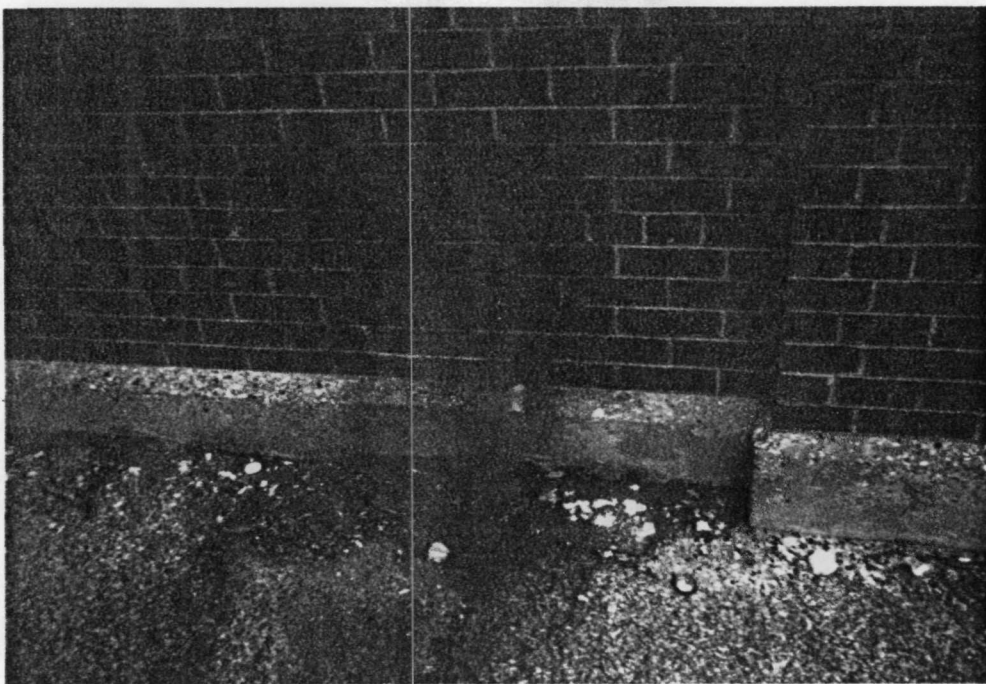
Sample BLD-001. Sample BLD-001 was collected outside the building. The sample, collected from the south side of the building outside Room 3, exceeded the RCRA levels for hazardous waste for chromium with a TCLP concentration of 110 mg/L.

SITE NAME: AUTODEPOSITION, INC. TDD #: T05-9505-018
 PHOTOGRAPHER: Brooks CAMERA: Ritz Quick Snap - 35mm
 DATE: 06/02/95 TIME: 1307
 DIRECTION: North
 SUBJECT: Closer view of staining of brick and sidewalk on the south side of the ADI site.

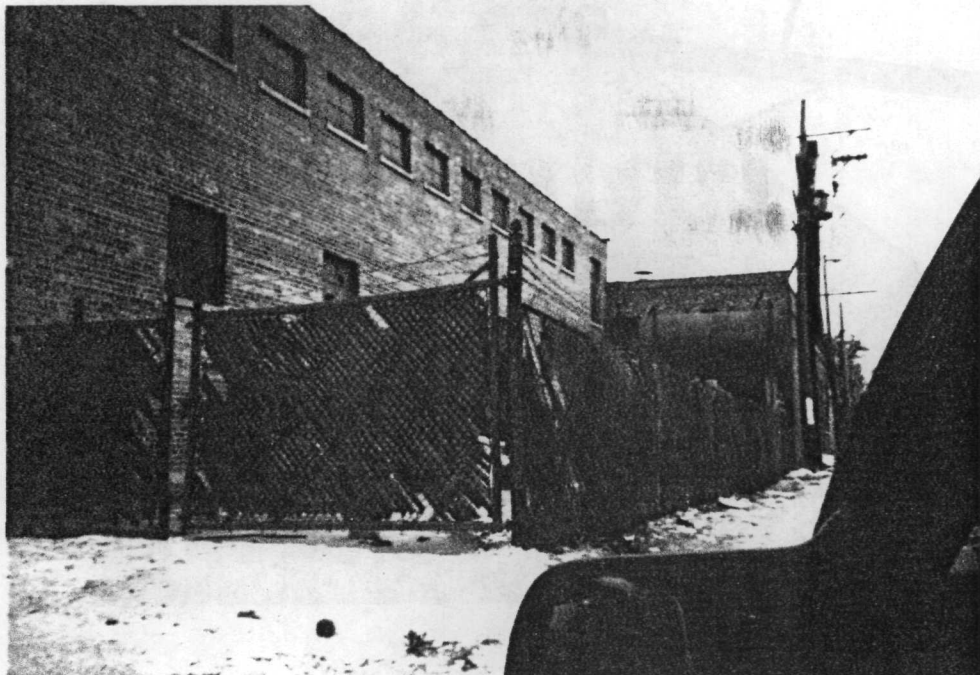
SITE NAME:	AUTODEPOSITION, INC.	TDD #:	T05-9505-018
PHOTOGRAPHER:	Brooks	CAMERA:	Ritz Quick Snap - 35mm
DATE:	06/02/95	TIME:	1315
DIRECTION:	Southwest		
SUBJECT:	Outside yard on the North side of ADI site which is bordered by an alley.

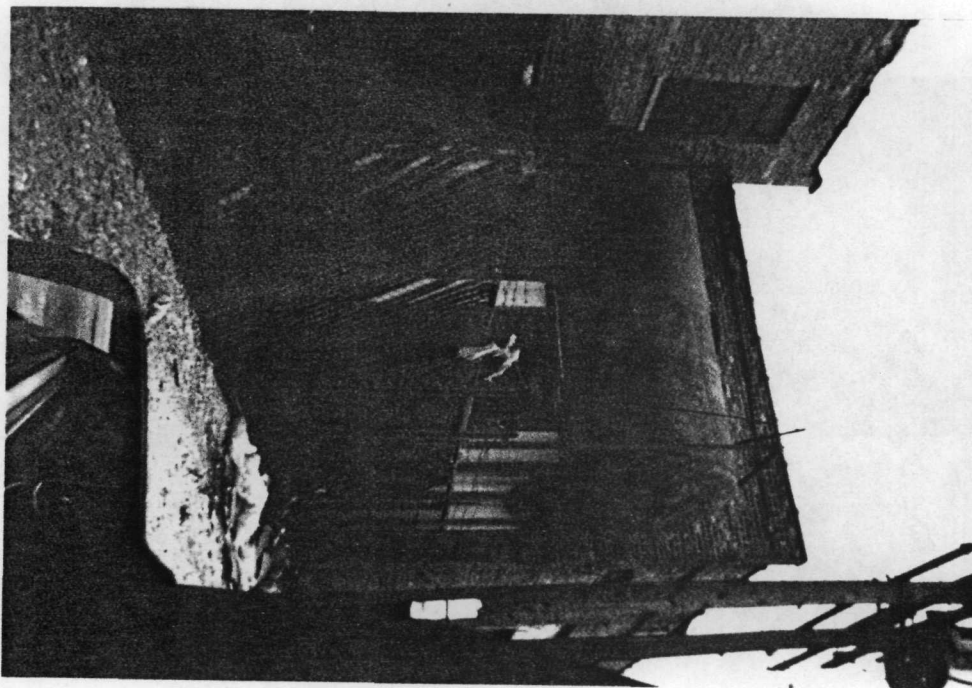
SITE NAME:	AUTODEPOSITION, INC.	TDD #:	T05-9505-018
PHOTOGRAPHER:	Brooks	CAMERA:	Ritz Quick Snap - 35mm
DATE:	06/02/95	TIME:	1317
DIRECTION:	West-Southwest		
SUBJECT:	5000 Gallon Sulfuric Acid Tank in outside yard.

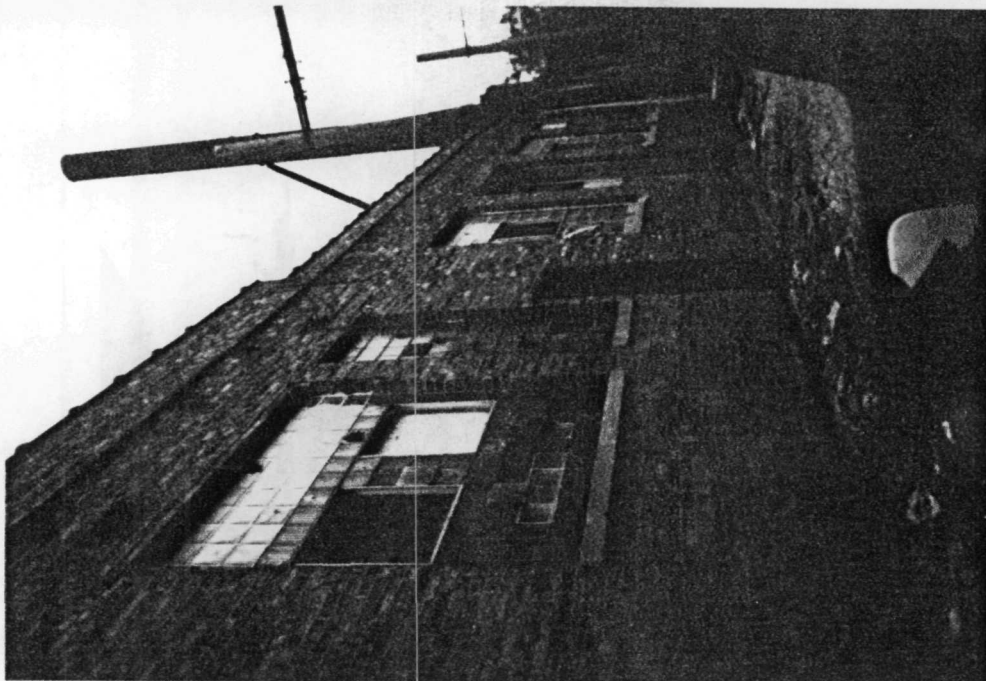
SITE NAME:	AUTODEPOSITION, INC.	TDD #:	T05-9505-018
PHOTOGRAPHER:	Brooks	CAMERA:	Ritz Quick Snap - 35mm
DATE:	06/02/95	TIME:	1320
DIRECTION:	West		
SUBJECT:	North side of ADI site. Note broken windows.

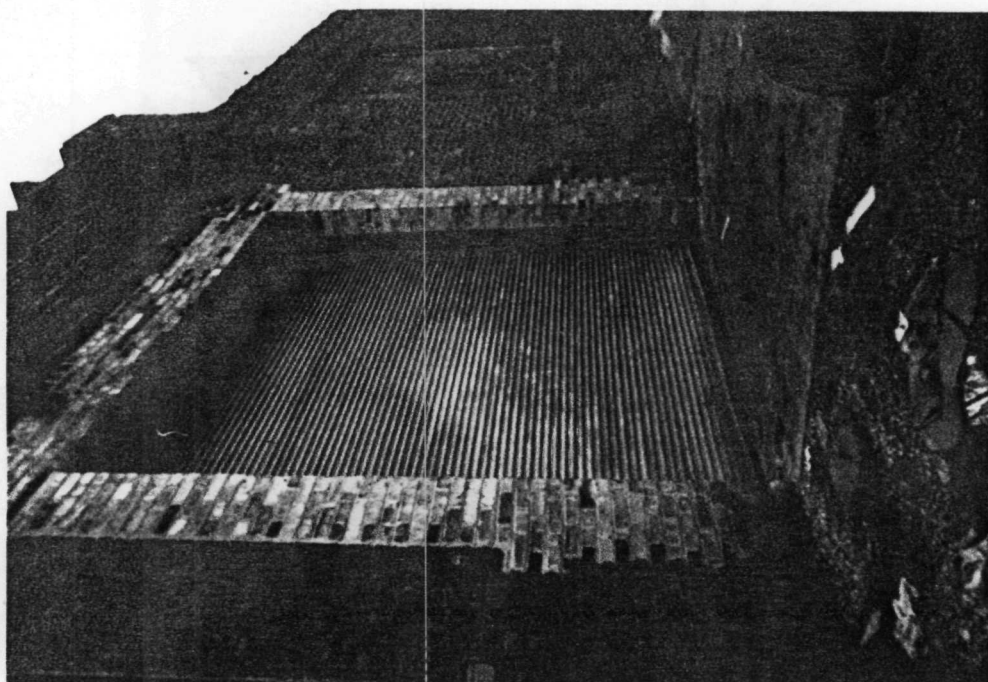
SITE NAME:	AUTODEPOSITION, INC.	TDD #:	T05-9505-018
PHOTOGRAPHER:	Brooks	CAMERA:	Ritz Quick Snap - 35mm
DATE:	06/02/95	TIME:	1324
DIRECTION:	Southwest - West		
SUBJECT:	Overhead door on North side of ADI site. Note debris scattered throughout the alley and that the door has been pryed open.

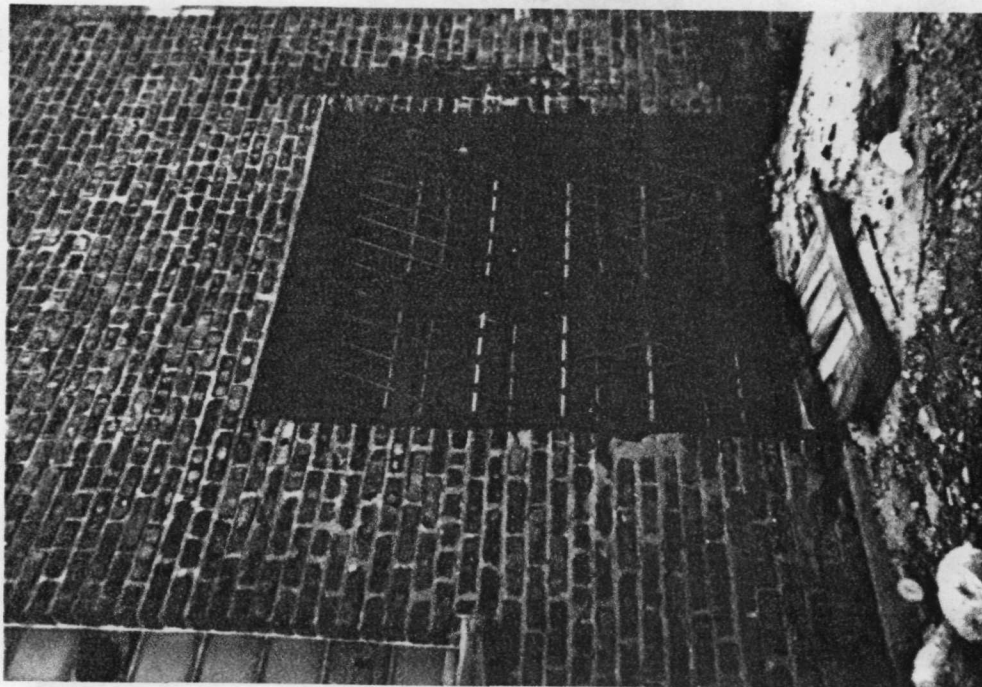
SITE NAME: AUTODEPOSITION, INC. TDD #: T05-9505-018
 PHOTOGRAPHER: Brooks CAMERA: Ritz Quick Snap - 35mm
 DATE: 06/02/95 TIME: 1328
 DIRECTION: Southwest
 SUBJECT: Door on North side of ADI site. Note burned wood and deteriorating structure.

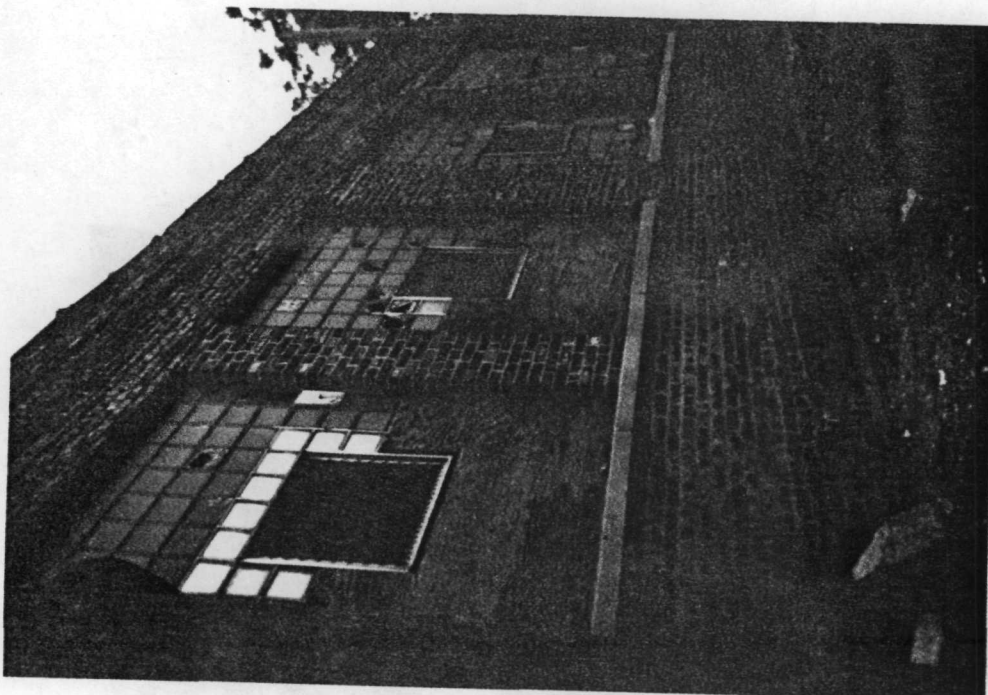
SITE NAME: AUTODEPOSITION, INC. TDD #: T05-9505-018
 PHOTOGRAPHER: Brooks CAMERA: Ritz Quick Snap - 35mm
 DATE: 06/02/95 TIME: 1330
 DIRECTION: Southwest
 SUBJECT: North side of ADI site. Note broken and boarded windows.

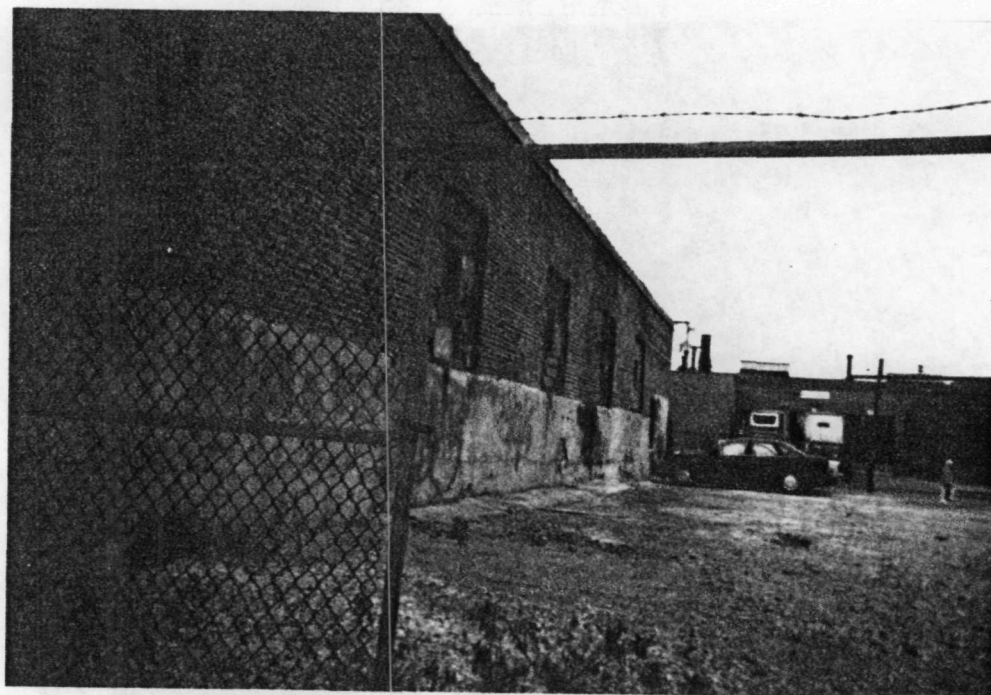
SITE NAME: AUTODEPOSITION, INC. TDD #: T05-9505-018
 PHOTOGRAPHER: Brooks CAMERA: Ritz Quick Snap - 35mm
 DATE: 06/02/95 TIME: 1335
 DIRECTION: Southeast
 SUBJECT: West end of ADI site. A fenced in parking area and outside wall of ADI site. Note staining of wall in several areas.

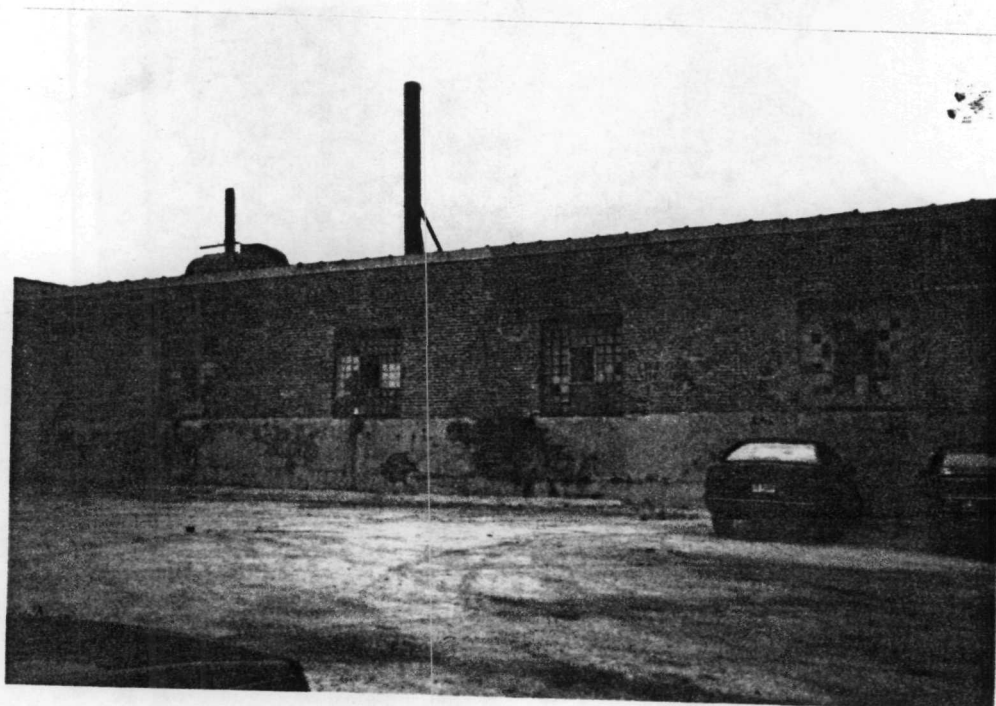
SITE NAME: AUTODEPOSITION, INC. TDD #: T05-9505-018
 PHOTOGRAPHER: Brooks CAMERA: Ritz Quick Snap - 35mm
 DATE: 06/02/95 TIME: 1340
 DIRECTION: East
 SUBJECT: West side of ADI site. Note broken windows and stained walls.
